HYDRAULIC SCENIC LIFTS

DIRECT ACTING BOREHOLE – WATER INGRESSION

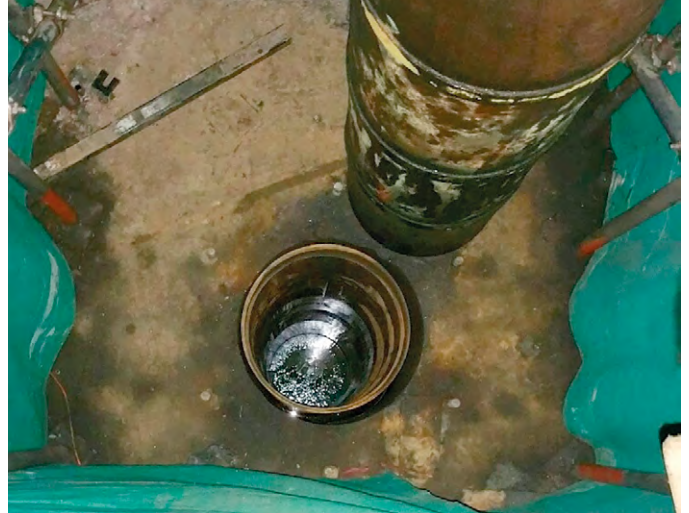
top image Steel sleeve pressed into place, liner being readied for lowering into sleeve · **bottom image** Steel liner welded and ready for lowering into the sleeve

Our next option was to use high pressure water jetting, and after discussions with the specialist contractor, a decision was made to use the jetting with the press. This proved to be a success and the new liner was installed. The modernisation was completed and the lifts are all now running reliably, much to everyone's delight.
