HYDRAULIC SCENIC LIFTS

DIRECT ACTING BOREHOLE – WATER INGRESSION

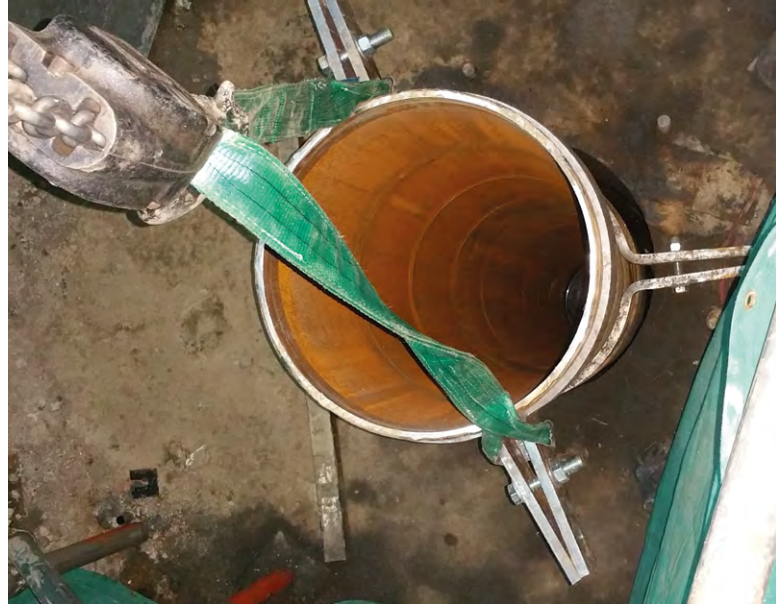
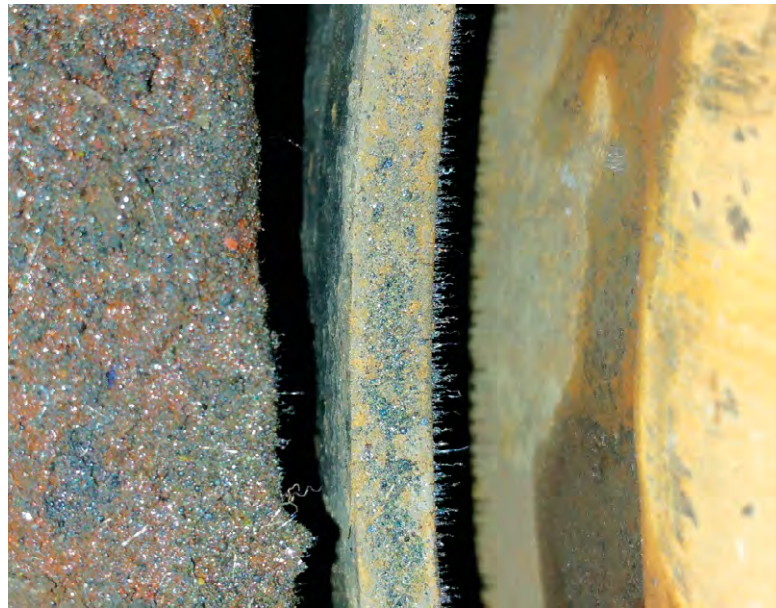
Of the four liners, the first one went down to the required depth and the second one stopped 2m short. The lift jack cylinder casing Hydratec removed was 11,460mm long, so something had stopped the MDPE liner at 10,500 mm. The MDPE liner was removed and a plumb tape was dropped into the borehole which gave an audible signal when the water level was reached. Water was found at 7000mm below the pit floor level, at 10,600mm the tape stopped and checking around the perimeter of the borehole liner, it showed the liner was blocked. A decision was made to agitate the silt in the bottom of the liner and remove it using high power suction. Initially, this proved successful but then a problem was experienced with silt refilling rapidly as soon as the suction stopped.

Initially, our site engineers could not understand why the silt kept refilling the liner. However, the problem was quickly identified after some investigation – the issue was the original liner material. Normally a liner will be manufactured from 6-10mm thick steel tube. This liner was manufactured from galvanised spiral wrap ducting, the sort used for air movement. Over the years this had corroded to virtually non existence, meaning the original cylinders on two of the four lifts were sitting in silt.

The task was how to replace the liner. The original ducting, in part, was still there and we had discovered small pieces of duct sucked up through the suction pipe and could see them in the settlement tank. As there were limited options, together with our client and the building owners, the decision was made to use a hydraulic tunnelling press to push a new steel sleeve made up of 500mm sections, into the ground.

After this, a new steel liner would be lowered down and welded together until the required depth was reached.
